GEOTECHNICAL ASSESSMENT REPORT

10-LOT SUBDIVISION, MANGAKURI BEACH

SR & BJ WILLIAMS CHARITABLE TRUST

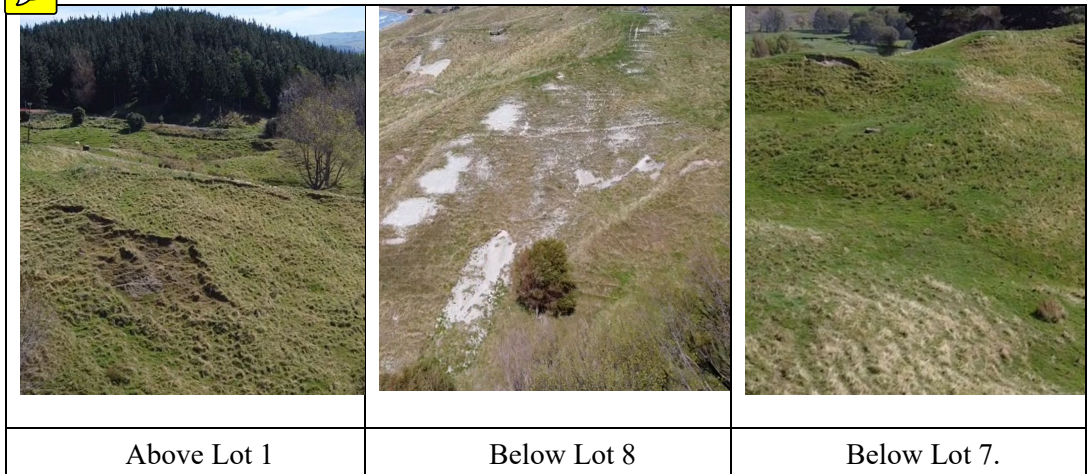
E 1: EXAMPLES OF RAINFALL INDUCED LANDSLIDES

These landslides appear to have been caused predominantly due to:

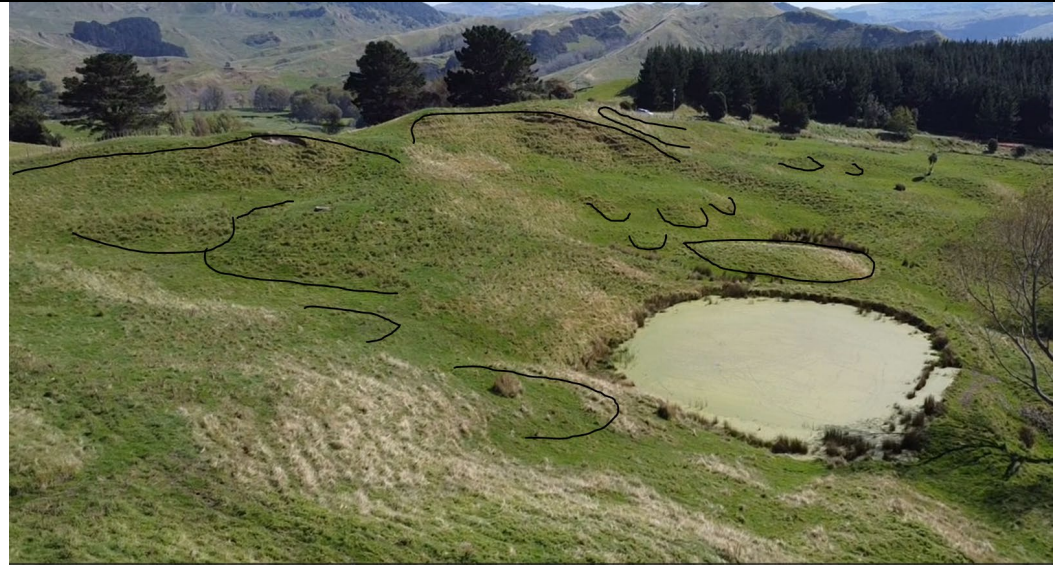
IMAGE 2: SEISMICALLY INDUCED LANDSLIDES

Seismically induced landslides are much larger and deeper and are the likely primary cause of instability that encompasses the subdivision.

Seismically induced landslides are the likely origin for the southern, central and northern gully headscarps and bulbous debris runouts observed in Figure 2a, 2b and Image 2 and indicated on Figures 3a & 3b.

Example of Seismically induced Landslide and debris flow below Lot 7 (left) and Lot 6 (central).

The future building platforms are intentionally located outside of observed active or inactive instability areas including debris runout zones.

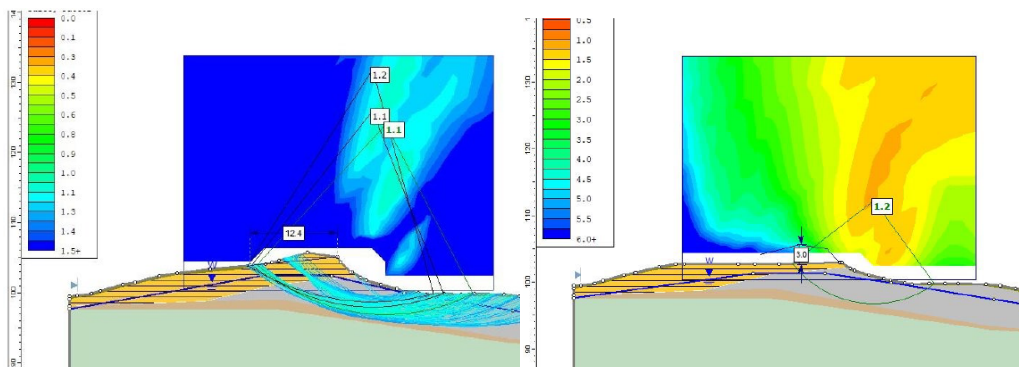
IMAGE 3: LOT 7 STABILITY ANALYSES RESULTS BEFORE EARTHWORKS (LEFT) AND AFTER RECOMMENDED EARTHWORKS (RIGHT)

The analysis did not meet the Target Criteria for pseudostatic (undrained) condition (FoS 1.1). This indicates that a rotational failure may be triggered during large seismic events.

The analyses achieved a factor of Safety under Pseudostatic, normal conditions of 1.2.
