Waipawa Solar Farm Flood Risk Assessment – Part 1

Prepared for Helios Energy New Zealand Ltd
Prepared by Beca Limited

12 May 2023

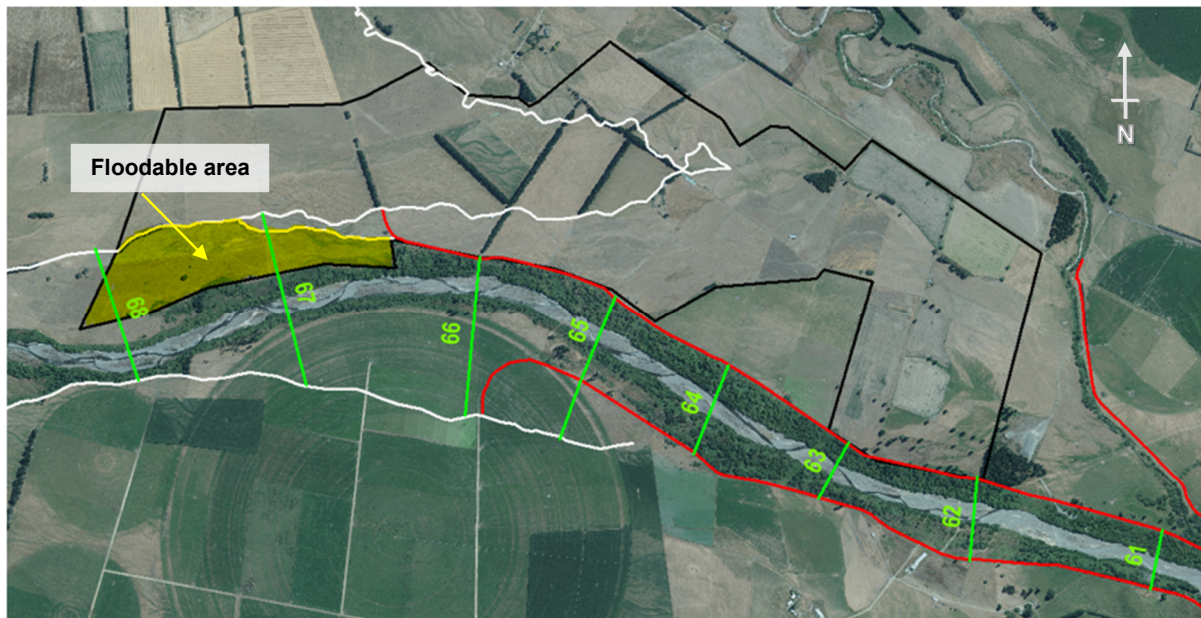
The cross-sections of the 1D flood model span between the terraces and/or stopbanks, as seen in Figure 4. Ongaonga Stream was included in this model, however its cross-sections are not plotted in Figure 4.

Figure 4: Cross-sections (green lines) from HBRC 1D model.

The stopbank or terrace heights and the corresponding modelled water level for each cross section are summarised in Table 1. The model clearly indicates that in the 100-year event *the south-western part of the site will be subject to inundation*. This floodable area is highlighted in yellow in Figure 4.

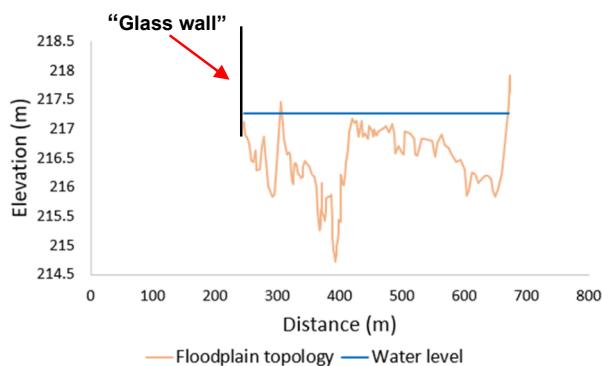
Figure 6 illustrates cross section 68, an example where terraces on both sides are included in the cross section. Cross section 67 is truncated on the left (north) side and does not include the terrace, as shown in Figure 5, therefore, a vertical 'glass wall' is assumed by the model. However, the terrace is well above the water level at this location and there is no risk of water spilling further into the site. The left terrace or stopbank is visible in all other cross-sections, and is at least 0.9 m higher than the modelled 100 year water level, meaning *no overtopping was modelled* in this event.

Figure 5: Cross section 67 topology and modelled water level.

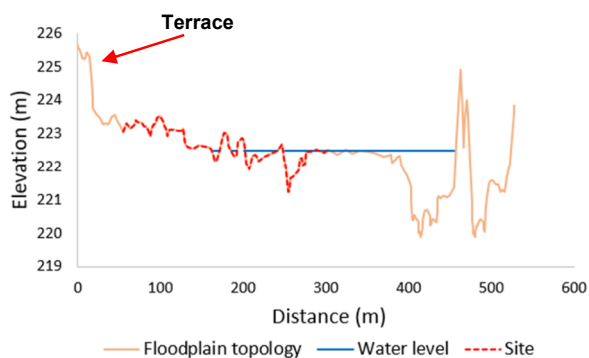
Figure 6: Cross-section 68 topology and water level.
