# **GEOTECHNICAL ASSESSMENT REPORT**

**10-LOT SUBDIVISION, MANGAKURI BEACH**

**SR & BJ WILLIAMS CHARITABLE TRUST**

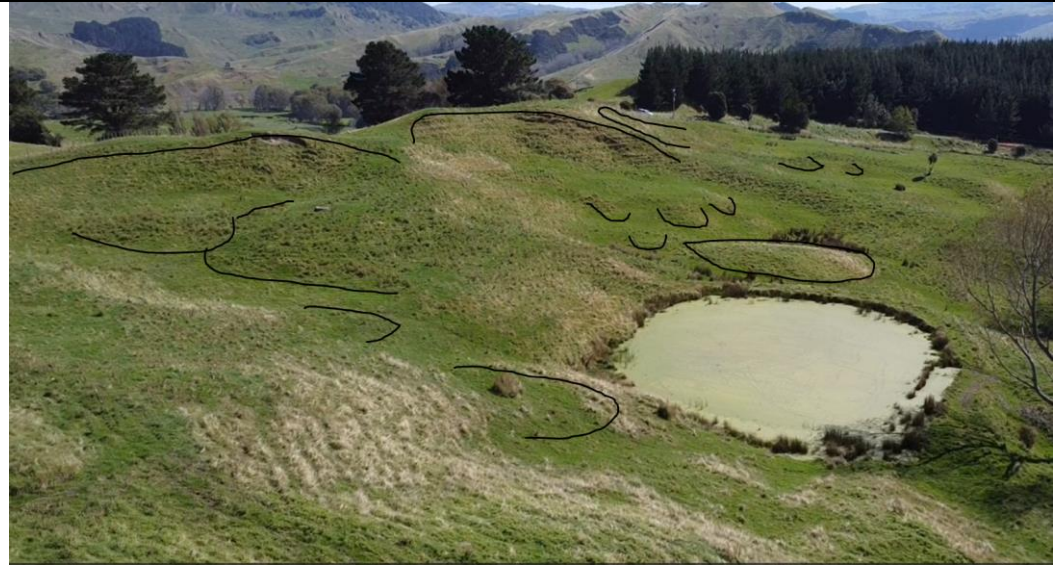
IMAGE 2: SEISMICALLY INDUCED LANDSLIDES

Example of Seismically induced Landslide and debris flow below Lot 7 (left) and Lot 6 (central).

Seismically induced landslides are the likely origin for the southern, central and northern gully headscarps and bulbous debris runouts observed in Figure 2a, 2b and Image 2 and indicated on Figures 3a & 3b.

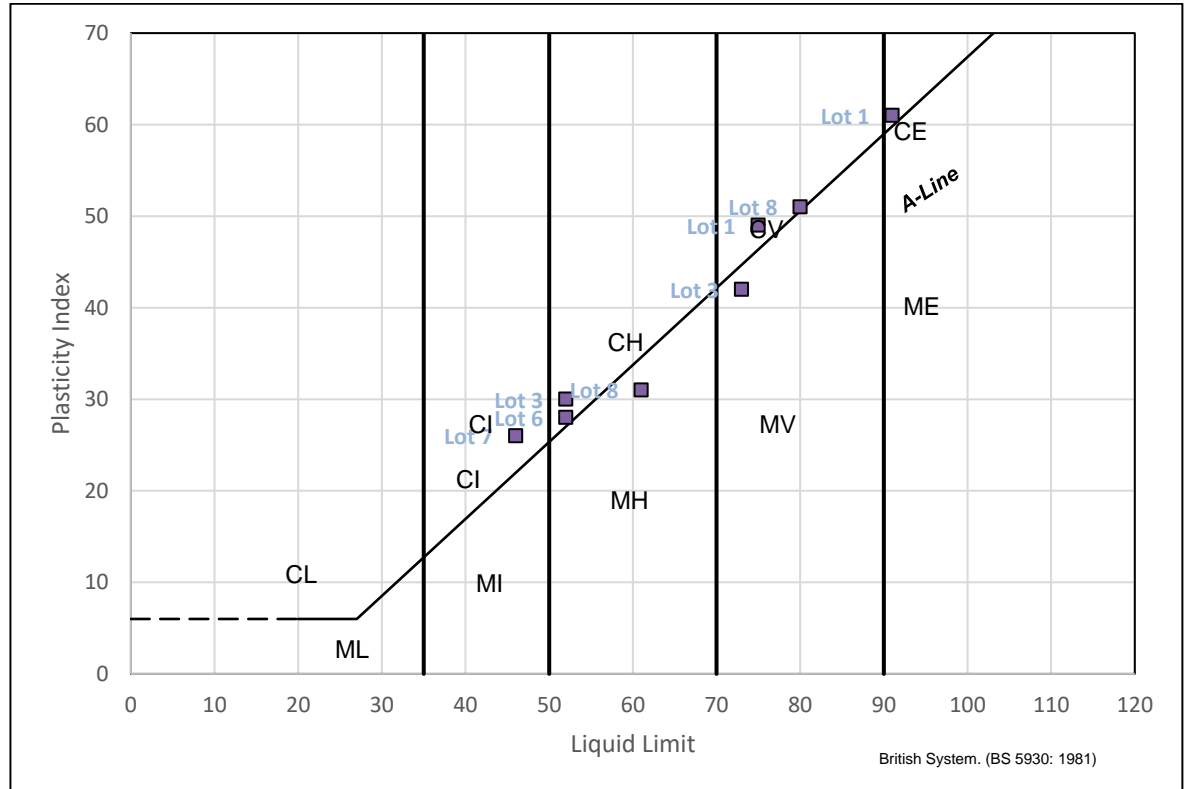
GRAPH 1: A-LINE PLOT (BS5930:1981)

The results of Liquid Limit vs Plasticity Index are Plotted against the A-Line (BS5930: 1981) (Graph 1) which indicates almost all samples sit above the “A-Line” and exhibit low to extremely plastic “Clay like” behaviour.

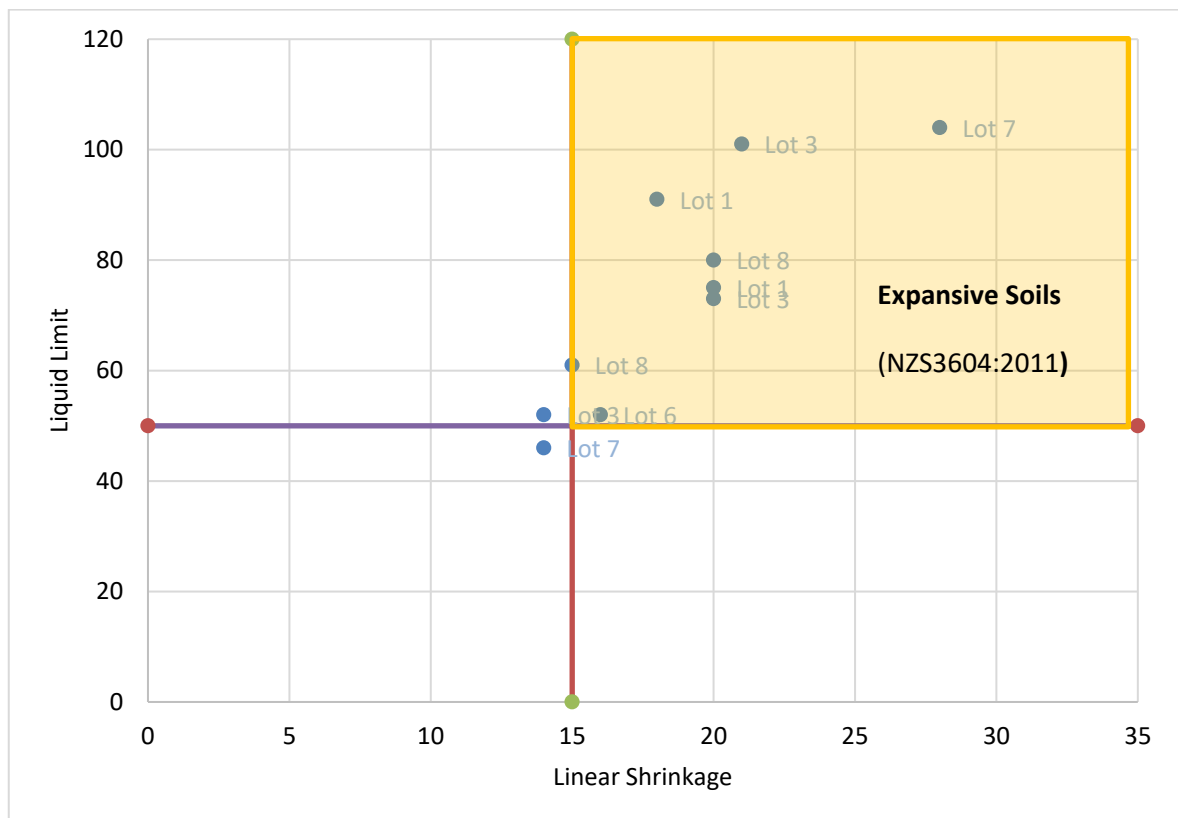
GRAPH 2: EXPANSIVE SOILS (NZS3604:2011).

The top right quadrant with eight (8) samples with Linear Shrinkage >15% and Liquid Limit >50% plotted in Graph 2 indicates “Expansive soils” in accordance with NZS 3604:2011, Section 17.

- Expansive and borderline expansive soils are in near surface soils at Lots 3 to 10 (upper slope) and Lot 1 & 2 (lower slope).
