Project Number: 3-C2144.01

Kairakau Water Supply Options Assessment

19 May 2020

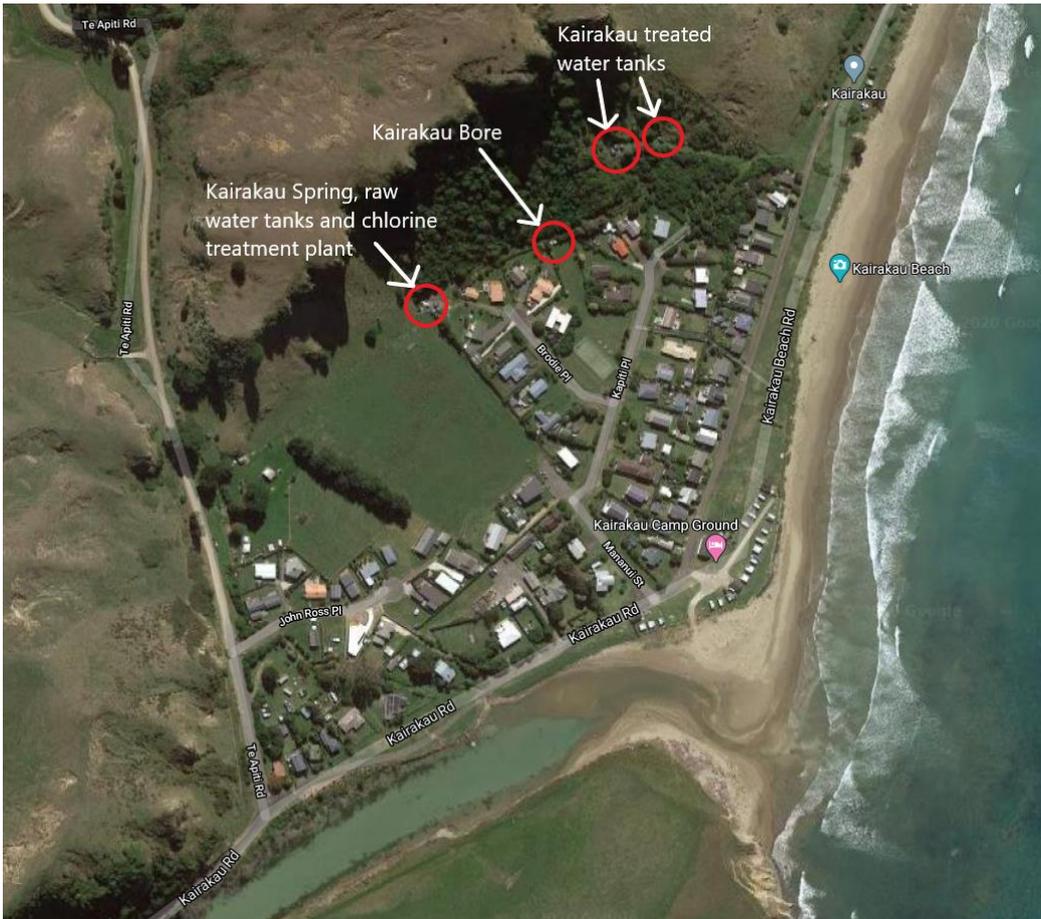
Figure 2-1 : Location of Key Kairakau Water Supply Elements

The scheme currently supplies 83 properties and the camping ground (approximately 20 sites). Water is pumped from two sources at the base of an adjacent hill; a shallow bore off Kapiti Place, and a spring off Brodie Place. Water is stored in raw water tanks, located next to the spring on Kapiti Place, before it is dosed with liquid chlorine and pumped up to four treated water tanks on the hillside above 21 Kapiti Place. Water is fed to the town via gravity mains from three treated water tanks which service the general consumers, and a fourth tank which supplies the campground exclusively. Each property has its own on-site storage tank which is supplied primarily by roof water, and supplemented by the water supply scheme when there is a deficit of roof water.

The bore and pump station are located at the bottom of the hill on Council reserve off Kapiti Place, as indicated in Figure 2-1. Access to the bore is through Council reserve and the site is currently not fenced off, meaning it can be accessed by the general public.

The spring, raw water tanks and pump station are located on an area of land behind 13 Brodie Place as indicated in Figure 2-1. The spring and pump station are located on Council land, but the raw water tanks are located on private property currently leased by Council. Access to the site is through private land and the site is currently fully fenced. The apron around the spring does not look to be in a good condition which may allow contamination into the supply.

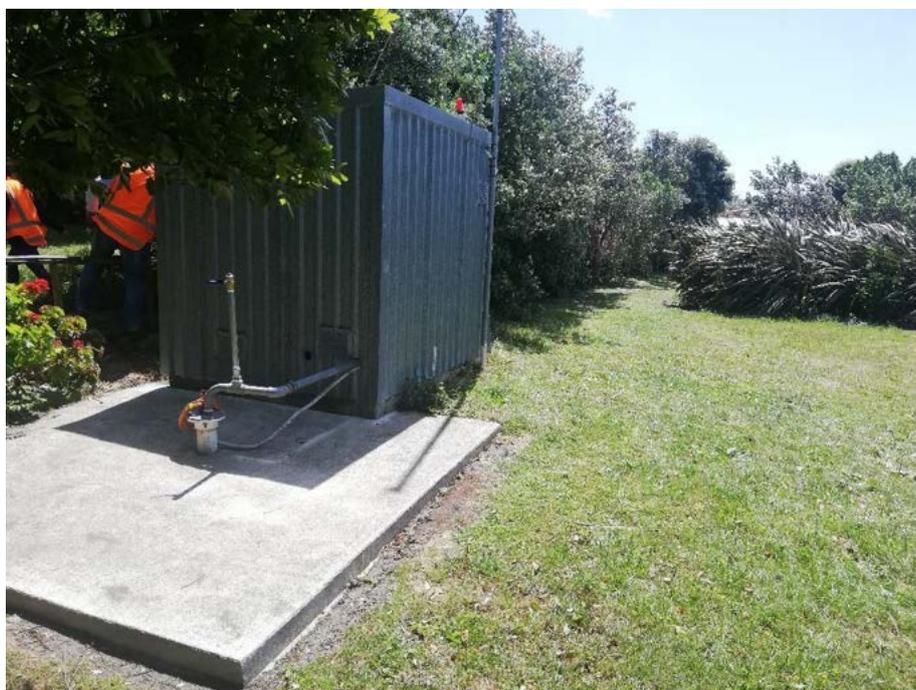
Figure 3-1 : Existing bore and pump shed

The bore is consented to take up to 605 m³ over a 7-day period at a maximum rate of 1 L/s. The bore was redeveloped in January 2020, and information available suggests that it has a sustainable yield of 0.7 L/s.

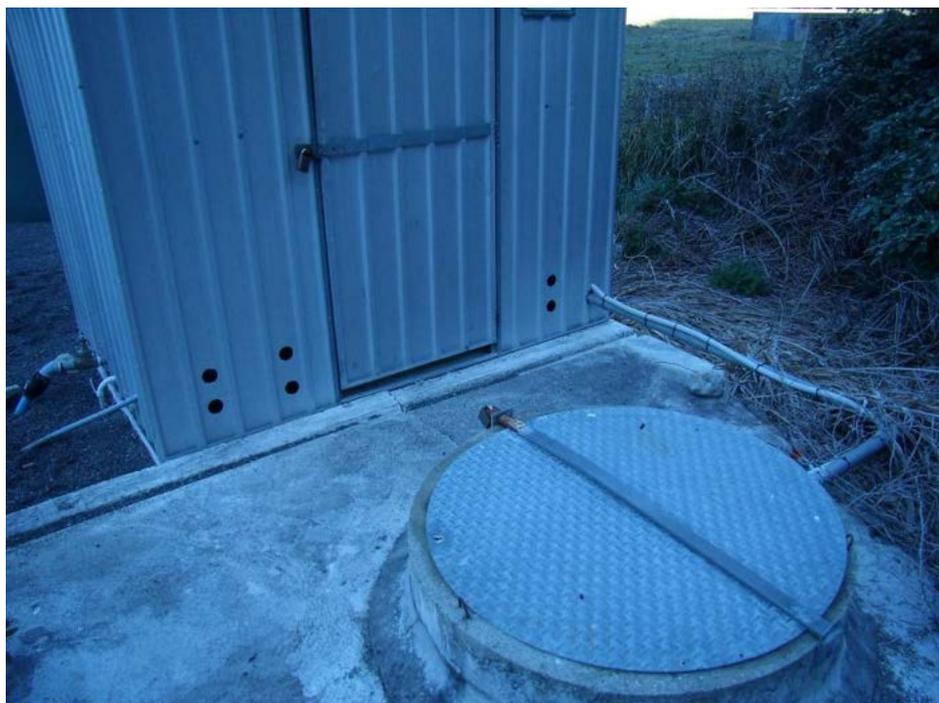
Figure 3-2 : Existing spring

Similarly to the bore, the spring has consent to take up to 420 m³ in a seven-day period at a maximum rate of 0.7 L/s. A step drawdown test was undertaken for the spring in January 2020 and it indicated that the spring can be pumped reliably at a rate of up to 1.2 L/s.

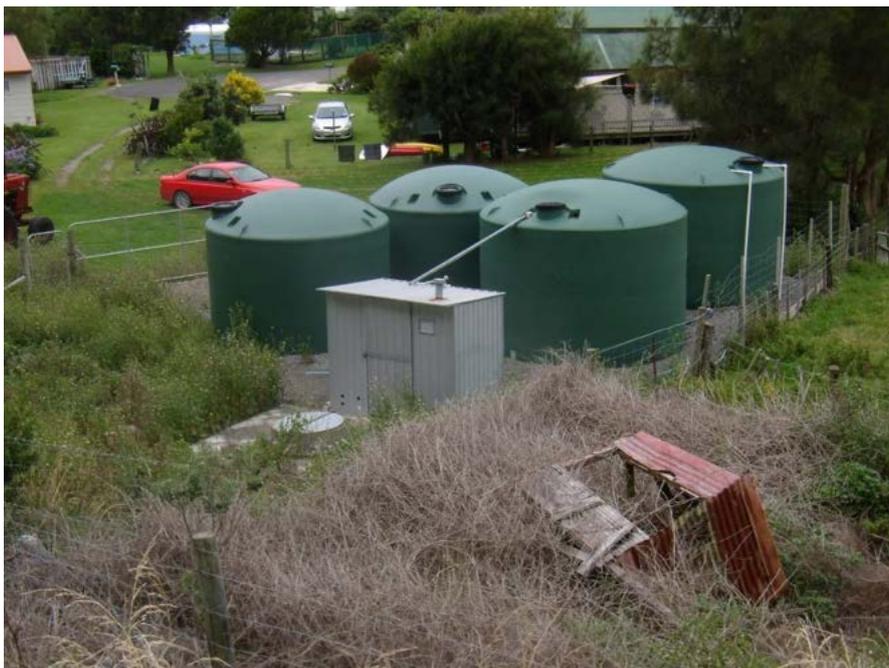
Figure 3-3 : Raw water tanks, spring and pumping station

There are four 25 m³ tanks which store raw water from both the spring and the bore, giving a nominal 100 m³ of raw water storage in total. The raw water tanks are located next to the spring, on private land leased by council, and access to them is through private land. The site is fully fenced, albeit with a low level of security.

- Replace damaged treated water tank to maximum existing storage capacity.
- Assess condition of concrete tank and repair/replace if necessary to provide security for treated water.
- Relocate raw water tanks onto Council reserve next to the bore site so council can be assured they will not have to acquire land or relocate in the future.
- If Kairakau does continue to run out of storage during peak demand, additional storage can be added.

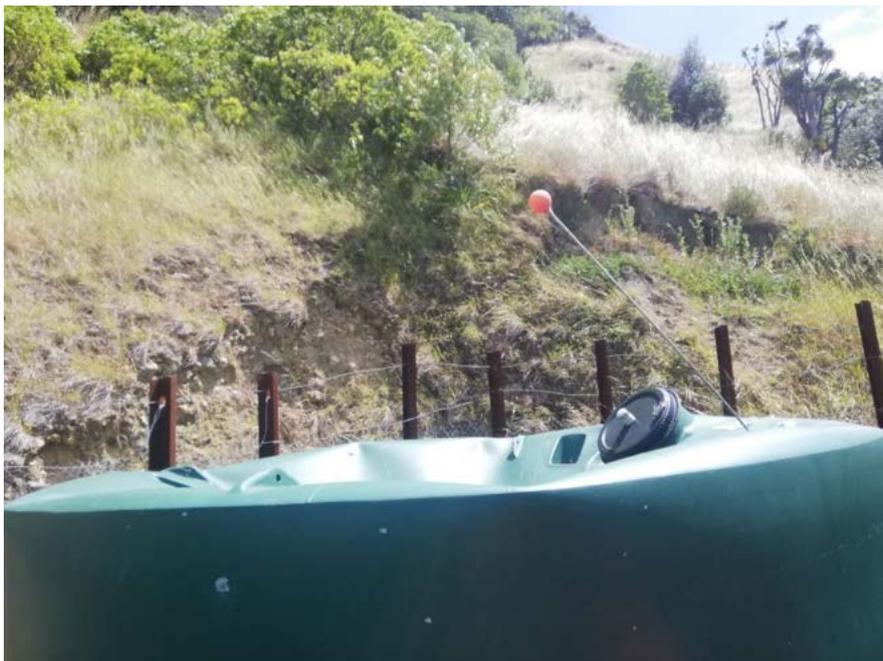
Figure 3-4 : Damaged treated water tank

There are four treated water tanks including three 25 m³ plastic tanks located on the side of the hill above 21 Kapiti Place which service general consumers, and one 20 m³ concrete tank which is located nearby but further down the hill, and which feeds the campground exclusively. Access is limited, via a narrow farm track and the site is currently not fenced off. These tanks give a nominal 95 m³ of treated water storage, however one of the plastic tanks has been damaged so only two of the plastic tanks are operational, meaning currently there is only a nominal 70m³ of treated storage.

- Maximum storage capacity is not being utilised as one of the treated water tanks is damaged.
- The condition of the concrete tank is unknown so the reliability of it is unknown.
- The location of the raw water tanks is on private property which could cause Council issues in the future if the lease is not renewed and land can't be acquired.

- Replace the damaged treated water tank to maximise storage capacity.
- Assess the condition of the concrete tank and repair/replace if necessary. This will increase the reliability of the tank
- Assess the condition of pump stations and pumping mains and upgrade where required.
- Fully fence the bore site and treated water tank site to prevent unauthorised access and protect assets from vandalism.

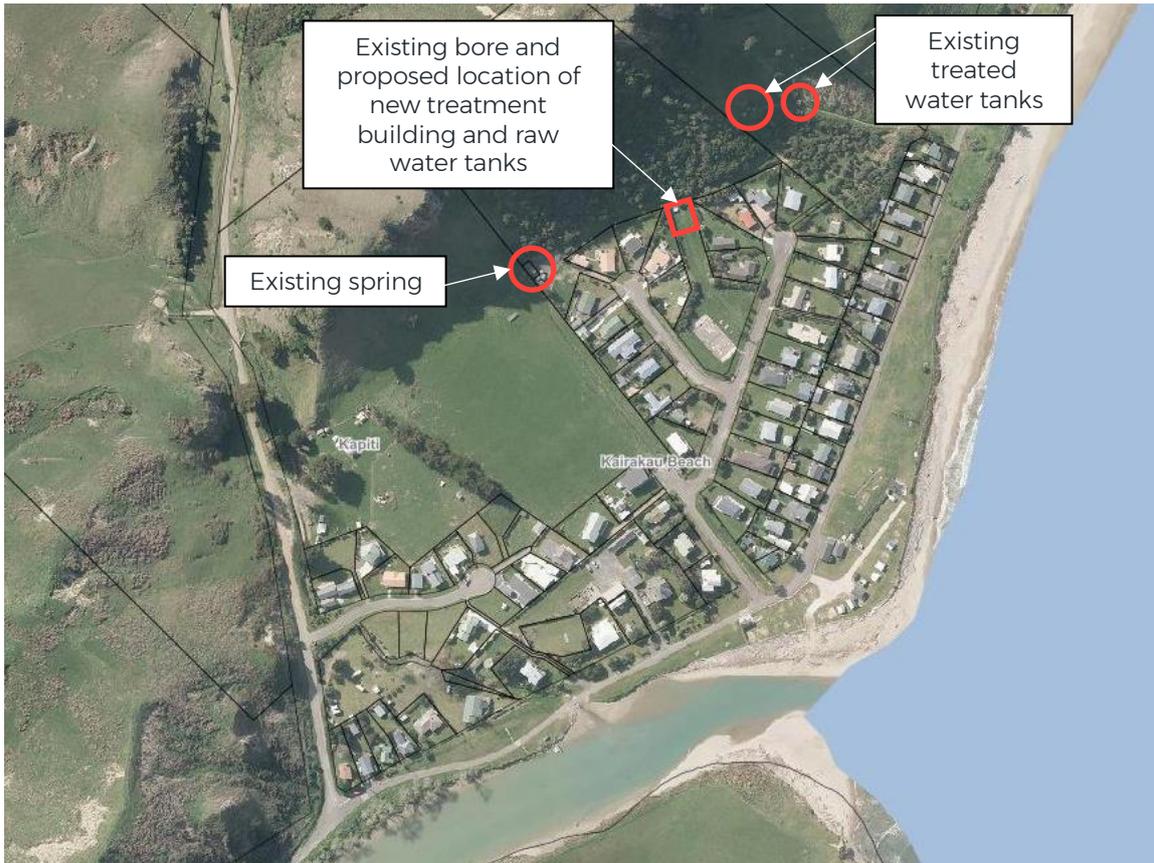
Figure 4-1 : Map of proposed location of new treatment plant and raw water tanks

- Identify critical areas where pipe upgrades are required to improve reliability of the reticulation system.
- Assess the leakage rates and undertake further leak detection if required to identify high leakage areas. Repair or replace leaking pipelines to decrease water lost through leakage.
- Relocate the existing raw water tanks onto council land.
