Takapau WWTP - Surface Water Assessment of Environmental Effects

Prepared for Central Hawke's Bay District Council

Prepared by Beca Limited

28 April 2021

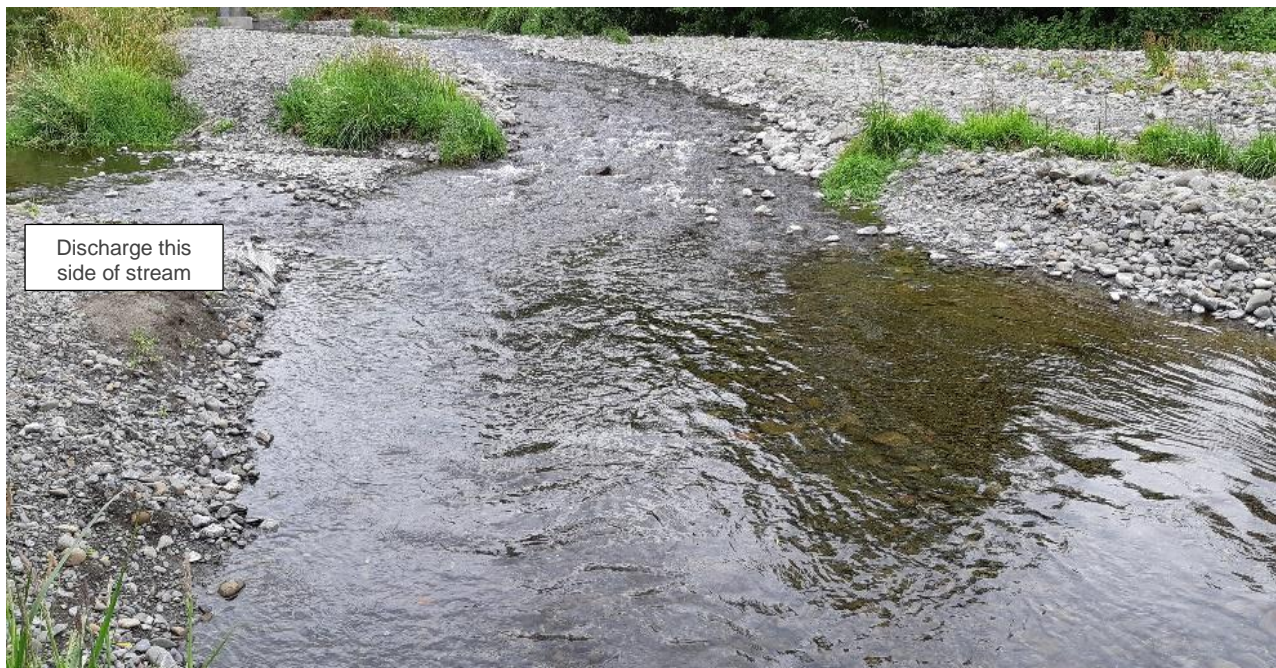
The section of the Makaretu River around the treated wastewater discharge is a relatively shallow braided river with a gravel substrate (Figure 3). There are two semi-permanent river braids, each approximately 10 m wide, that join together ~50 m downstream of the treated wastewater discharge. The width of the river gravel plain is approximately 50 m at the point of discharge. Historical imagery from Google Earth indicates that the main branch of the river shifts across the braid plain at a sub-annual timescale.

Figure 3. Makaretu River at point of discharge looking upstream

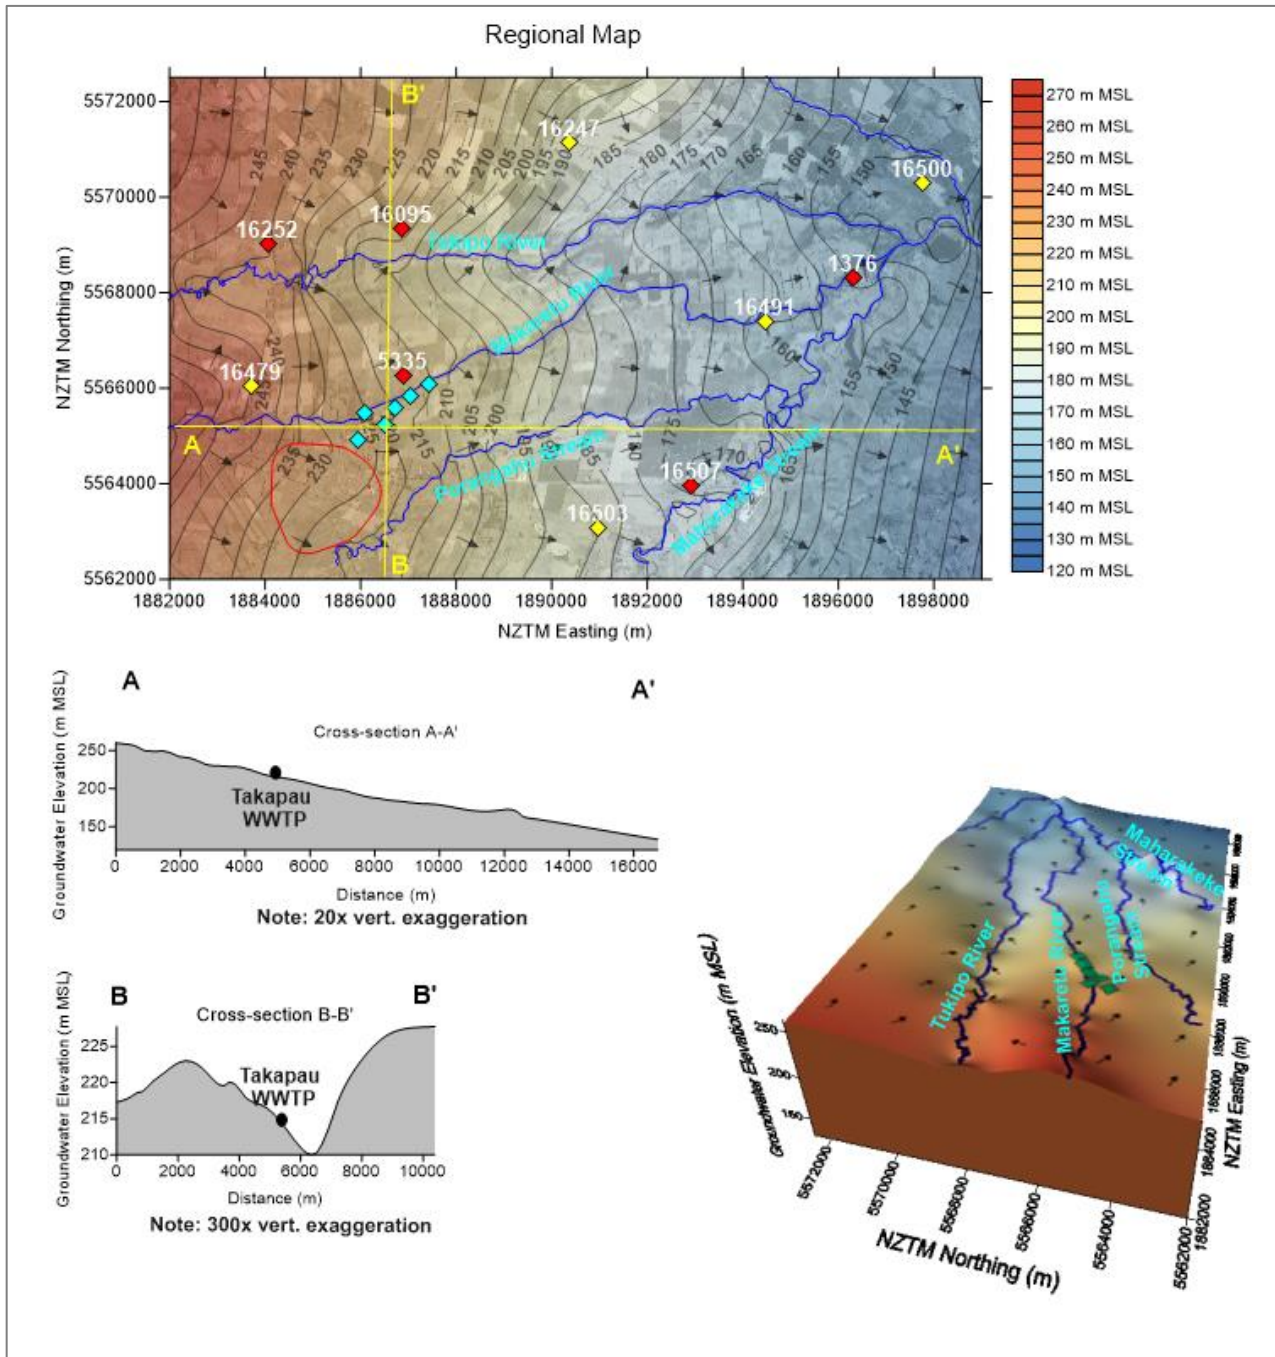
Figure 7: Regional conceptual hydrogeological model. The WWTP is located at the intersection of the cross-section lines. Red circle to SW is the Source Protection Zone for the Takapau water supply bore. Regional bores shown as red and yellow diamonds and local piezometers shown by blue diamonds. Contours indicate the water table elevation in m MSL and arrows indicate the interpreted groundwater flow direction.

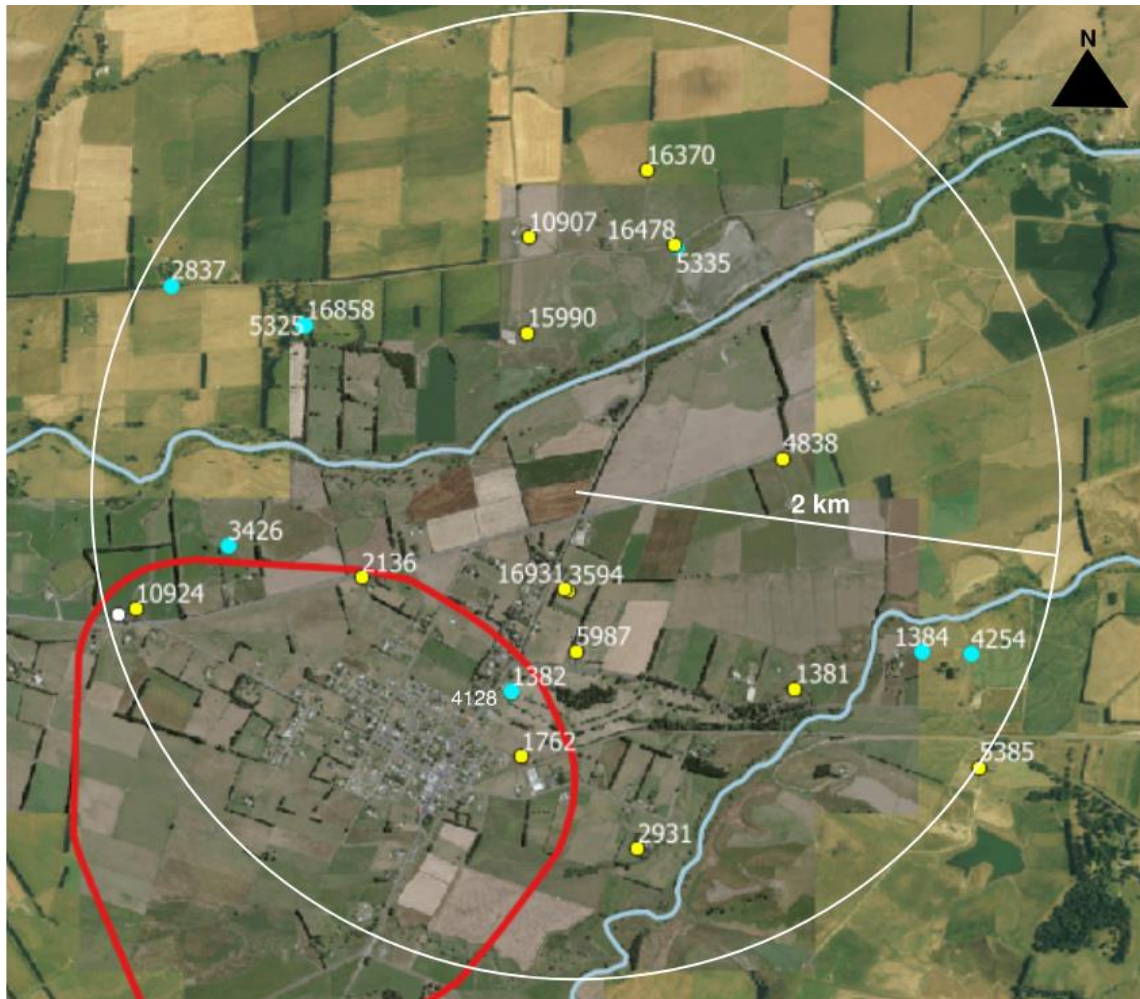
Figure 9: Bores within 2 km of the WWTP. Red line is SPZ surrounding the Takapau water supply bore 1762. The yellow dots show bores deeper than 30 m, while the blue dots show the bores shallower than 30 m.

- The water take consent associated with bore 1762 is the Takapau community supply. According to its HBRC log (Appendix C), this bore is screened from 31.0 to 33.5 m BGL and there is approximately 22 m of lower permeability units (comprised of multiple clay layers) above the screened interval. These units are likely to provide some hydraulic separation between the pumped aquifer and the shallow groundwater. Further the SPZ is presumably based on an assessed extent of drawdown and suggests that this does not extent a significant distance downgradient.
